Inspection Report

84 Grand Ave, Toms River, NJ 08753

Inspector Joe
Home Inspections, LLC

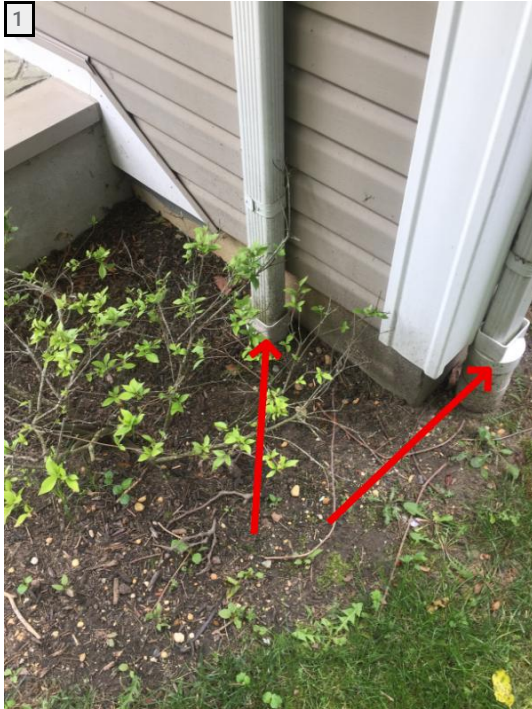
Underground Drainage Discharge End Point Cannot be Determined

Location	Exterior: Ground View
Impact	All discharge water should be away from the house. Water that is allowed to collect by house can seep into basement and can also cause structure problems
Suggested Action	Monitor during rain to be sure they are not clogged

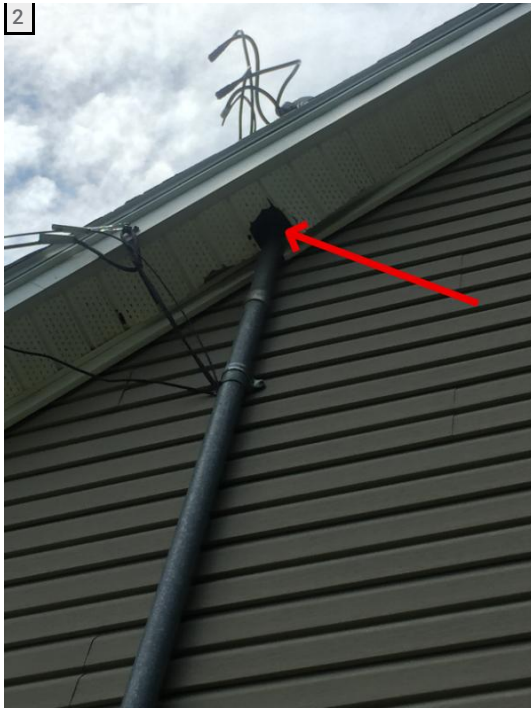
Vinyl fascia is damaged

Location	Exterior: Ground View
Impact	With damaged fascia, the wood that the vinyl is covering is exposed to the elements potentially causing premature aging
Suggested Action	Replace the run of fascia that is damaged

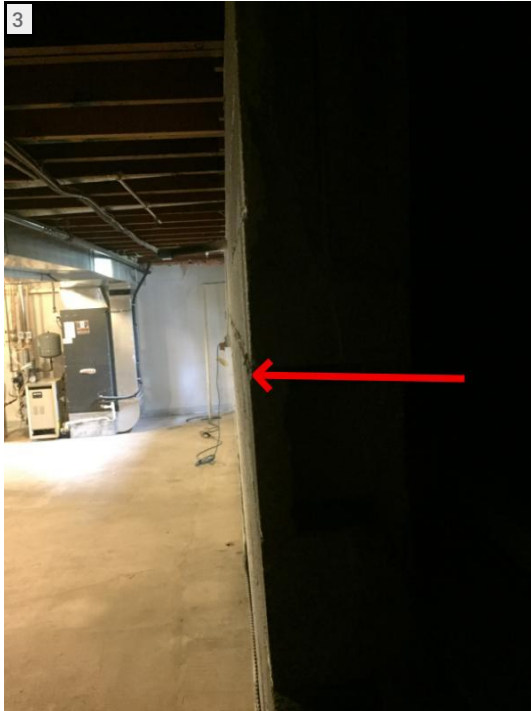
Displaced causing the wall to be out of square

Location	Basement
Impact	The displacement may be stressing the structural integrity of the wall frame
Suggested Action	Have repaired by a building or remodeling contractor

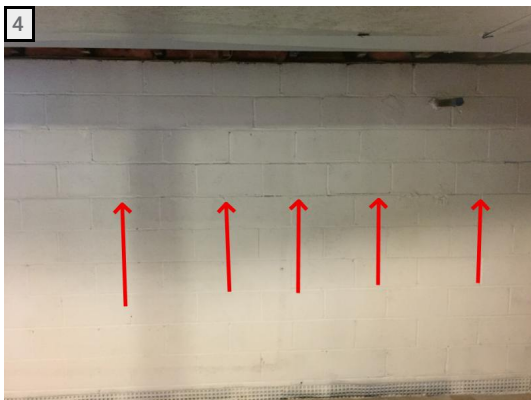
Exhibits moderate to severe horizontal cracking

Location	Basement
Impact	The cracking may worsen causing structural foundation issues
Suggested Action	Have assessed by a structural engineer to recommend repairs

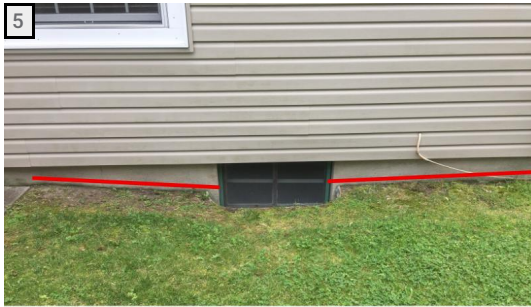
Does not have a positive grade

Location	Exterior: Ground View
Impact	Directing more moisture towards the foundation increases the risk of moisture intrusion
Suggested Action	Monitor the area for moisture buildup. Should it arise, If possible, regrading the area to achieve a slope away from the home. If regrading is not possible, add drain tile to re-direct water away from the home. Also, consult with a licensed waterproofing contractor
Other Information	Water should be directed away from all standing foundations to prevent potential water intrusion. The drainage strategy of the foundation is important. Expansive soils can be very destructive to the foundation if the moisture content of the perimeter varies

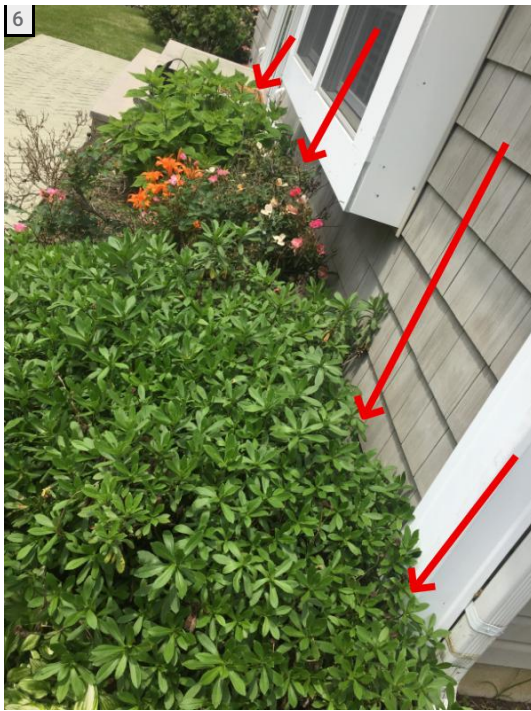
Shrubbery is in contact with home or siding

Location	Exterior: Ground View
Impact	The shrubbery provides an environment where moisture and/or insects could intrude
Suggested Action	Regularly trim the shrubbery to achieve a clearance of at least 6 - 8 feet

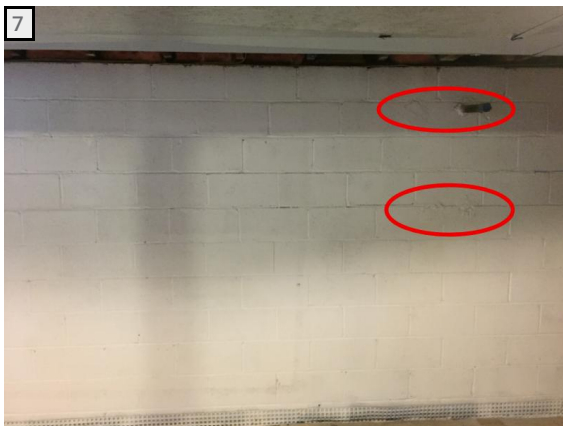
Patching on wall could be from existence of underground oil storage tank that have been removed or decommissioned. Any house built prior to 1975 is suspected to having or having had an underground oil tank.

Location	Basement
Impact	By purchasing a property with an underground oil tank, the property buyer may be taking legal liability for a tank, even if they never used the tank.
Suggested Action	Ask seller for any information on existence of underground oil storage tank and to provide any documentation on removal or decommissioning. If not know then contact qualified contractor to perform an oil tank sweep of the property

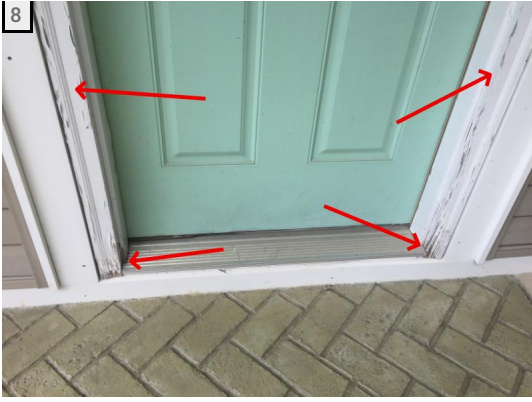
Paint peeling on trim and not caulked

Location	Exterior: Ground View
Impact	Wood exposed to the elements will absorb moisture and rot
Suggested Action	paint trim and caulk seems
